Specially-Designed Six-Part Self-Sealing Repair Clamp Prevents Costly Shutdown

Project: On-Line Leak Repair of Crack on High-Pressure/ High-Temperature Critical Line

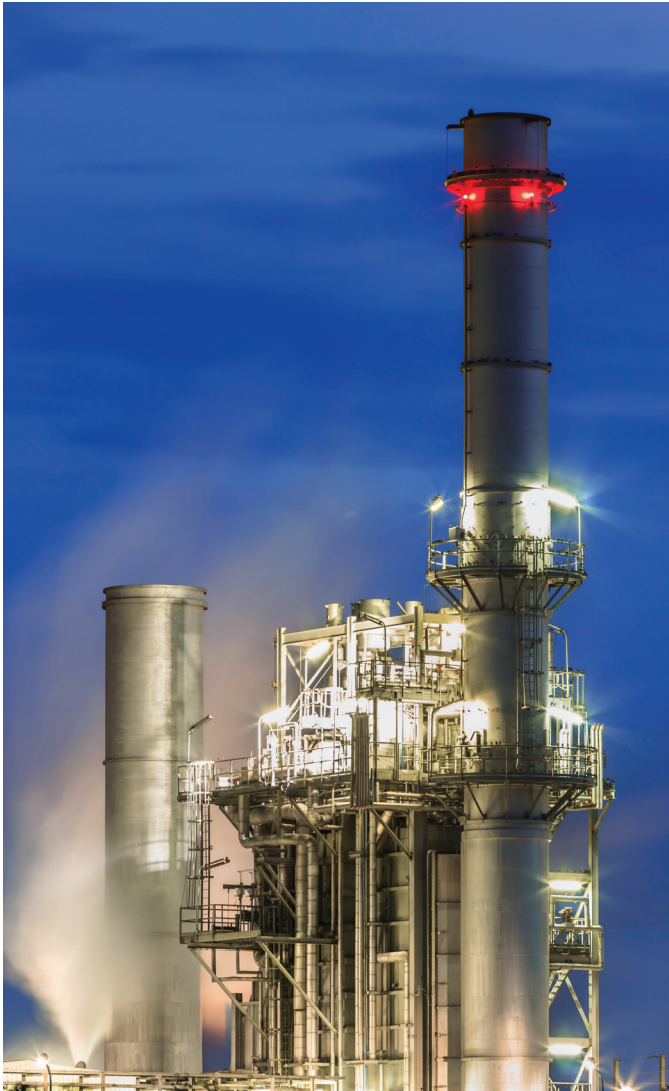
Need and Challenge: The ExxonMobil Mossmorran Chemical Plant detected a small crack on a critical line, operating at pressures of up to 84 bar g (1220psi) and temperatures of some 480°C. The crack had formed between the 16-inch pipe and the branch connection that attached it to a 20-inch header. Although the repair was not termed immediately dangerous by ExxonMobil engineers, repair was clearly essential and, given the operating pressures and temperatures involved, it was initially thought that shutdown was the only option.

Not only was there the issue of complex geometry to consider in designing the solution, but a further consideration was the fact that there was an immovable obstruction just 100mm away from the 180° return, making access awkward. TEAM's solution was a specially-designed six-part self-sealing repair clamp, mitered to match the geometry of the pipeline. Fluoro-elastomer was employed providing a high integrity seal, which is compatible with the hydrocarbon line contents over the required design life of the encapsulation. Once fitted, the enclosure was injected with resin to provide the defective pipeline with support.
